Navajo Abandoned Uranium Mine

Site Screen Report

Last Chance AUM Site

August 2010

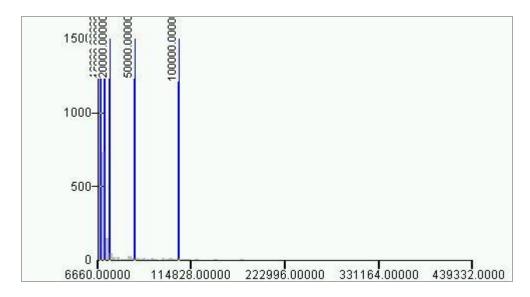
The following chart and statistics were generated by ESRI ArcGIS 9.3.1, and show the general distribution of the site gamma radiation measurements. The horizontal X axis represents the gamma radiation reading levels in cpm (lowest levels to the left). The vertical Y axis represents the frequency of each gamma radiation level.

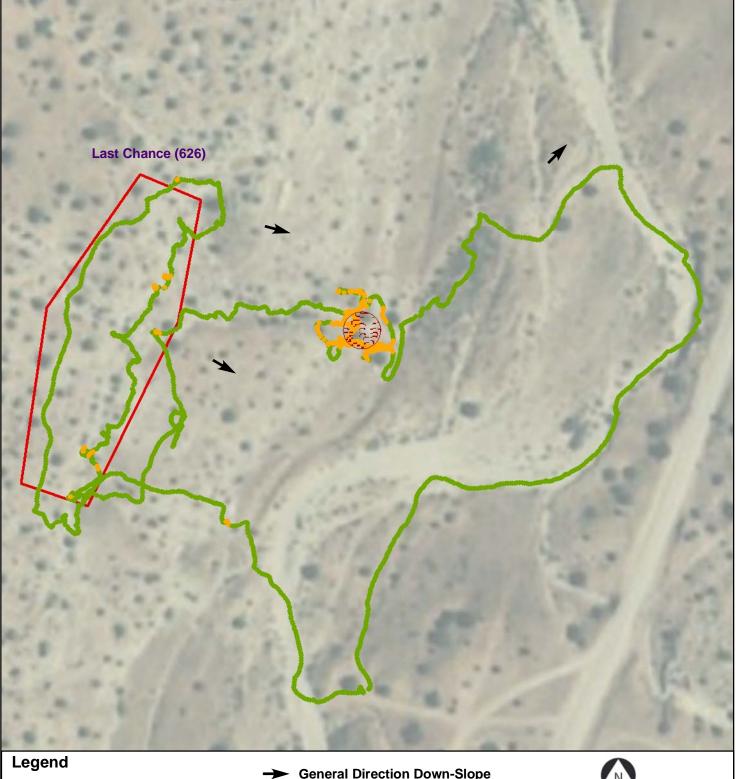
Figure 1 - Gamma Radiation Measurements, Above Two Times Background
Last Chance (626)
Sweetwater, Navajo Nation

A total of 2,520 gamma radiation measurements were collected from the mine site, ranging from 6,660 cpm to 439,332 cpm. Measurements collected in the vicinity of the waste debris were found at levels ranging from approximately 70,000 cpm to 400,000 cpm. The measurements are represented in Figures 1 and 2.
